Property Inspection Report

Report Number: 060322CF1

Sample Report
Charlotte, North Carolina 28210

Date of Inspection: Saturday, June 4, 2022

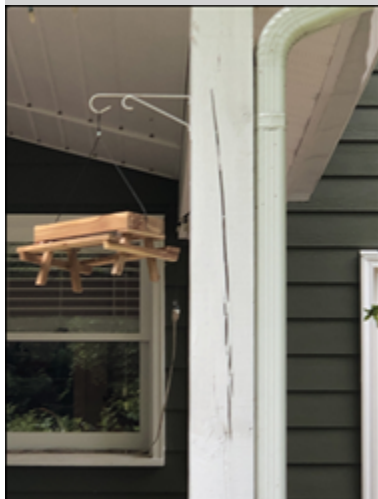
(A2 - 1.4) Porch

The porch columns are weathered and starting to split. Repair and painting is needed to prevent further damage and decay. A general repair person should be consulted.

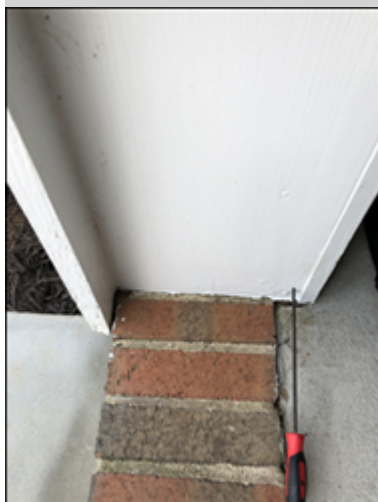
(B1 - 1.1) Main House Front

The wood trim pieces for the siding system are decayed at the corner locations. The corner trim provides a finished edge for siding and protects the underlying sheathing. Decay of the corner trim can allow water to enter behind the siding and result in damage to the framing. A licensed general contractor should be consulted for an invasive inspection to determine the extent of the damage to underlying components and make necessary repairs to ensure the weathertightness of the cladding system.

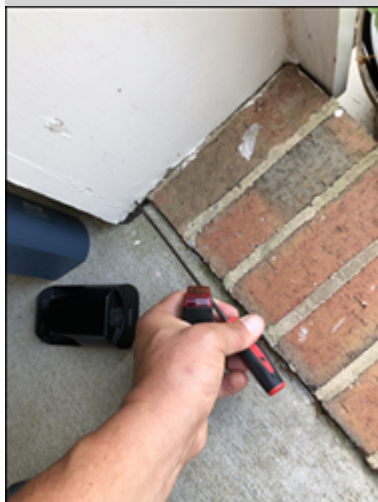
(B1 - 1.2) Main House Front

The wood trim pieces for the siding system are decayed at the corner locations. The corner trim provides a finished edge for siding and protects the underlying sheathing. Decay of the corner trim can allow water to enter behind the siding and result in damage to the framing. A licensed general contractor should be consulted for an invasive inspection to determine the extent of the damage to underlying components and make necessary repairs to ensure the weathertightness of the cladding system.

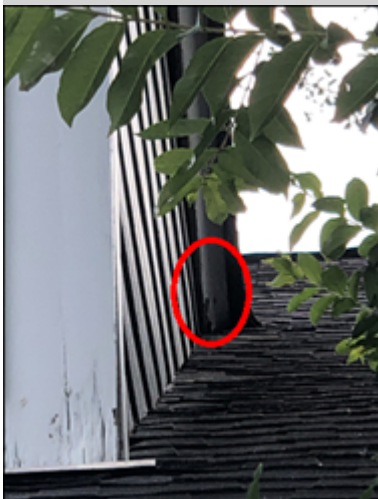
(B1 - 1.9) Main House Front

The wood trim pieces for the siding system are decayed at the corner locations. The corner trim provides a finished edge for siding and protects the underlying sheathing. Decay of the corner trim can allow water to enter behind the siding and result in damage to the framing. A licensed general contractor should be consulted for an invasive inspection to determine the extent of the damage to underlying components and make necessary repairs to ensure the weathertightness of the cladding system.

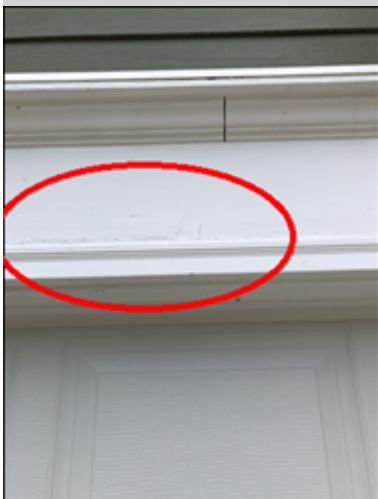
(B1 - 1.10) Main House Front

The wood trim pieces for the siding system are decayed at the corner locations. The corner trim provides a finished edge for siding and protects the underlying sheathing. Decay of the corner trim can allow water to enter behind the siding and result in damage to the framing. A licensed general contractor should be consulted for an invasive inspection to determine the extent of the damage to underlying components and make necessary repairs to ensure the weathertightness of the cladding system.

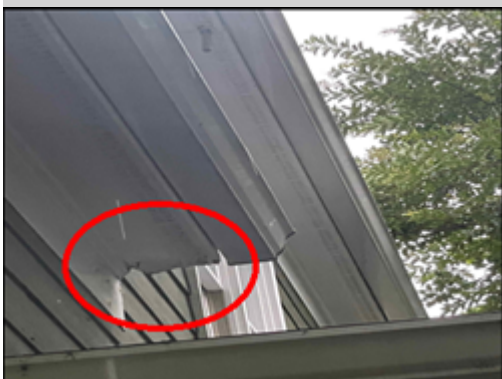
(B1 - 3.1) Main House Rear

The wood trim pieces for the siding system are decayed at the corner locations. The corner trim provides a finished edge for siding and protects the underlying sheathing. Decay of the corner trim can allow water to enter behind the siding and result in damage to the framing. A licensed general contractor should be consulted for an invasive inspection to determine the extent of the damage to underlying components and make necessary repairs to ensure the weathertightness of the cladding system.

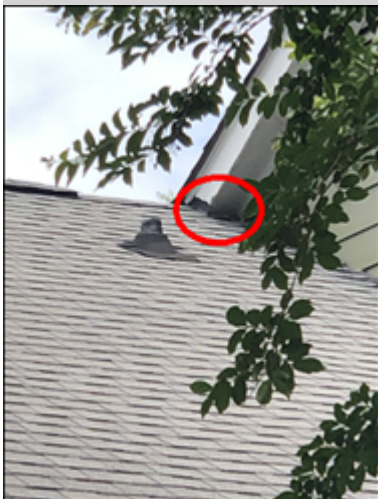
(B1 - 3.2) Main House Rear

The wood trim pieces for the siding system are decayed at the corner locations. The corner trim provides a finished edge for siding and protects the underlying sheathing. Decay of the corner trim can allow water to enter behind the siding and result in damage to the framing. A licensed general contractor should be consulted for an invasive inspection to determine the extent of the damage to underlying components and make necessary repairs to ensure the weathertightness of the cladding system.

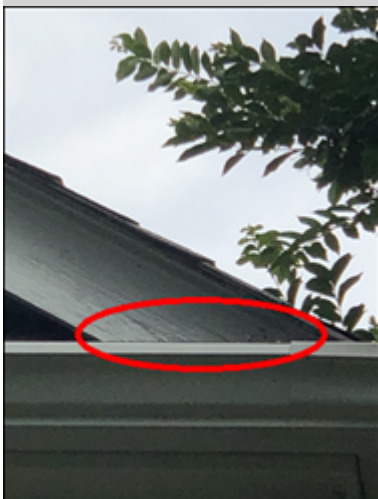
(B1 - 3.3) Main House Rear

The wood trim pieces for the siding system are decayed at the corner locations. The corner trim provides a finished edge for siding and protects the underlying sheathing. Decay of the corner trim can allow water to enter behind the siding and result in damage to the framing. A licensed general contractor should be consulted for an invasive inspection to determine the extent of the damage to underlying components and make necessary repairs to ensure the weathertightness of the cladding system.

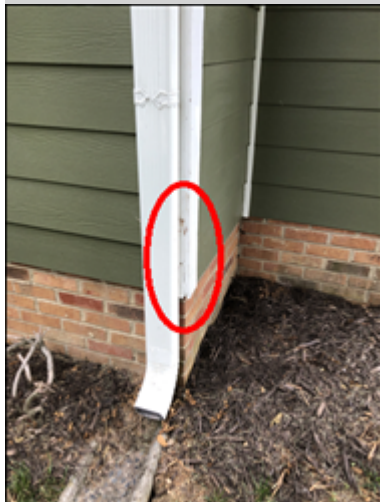
(B1 - 4.1) Main House Left

The wood trim pieces for the siding system are decayed at the corner locations. The corner trim provides a finished edge for siding and protects the underlying sheathing. Decay of the corner trim can allow water to enter behind the siding and result in damage to the framing. A licensed general contractor should be consulted for an invasive inspection to determine the extent of the damage to underlying components and make necessary repairs to ensure the weathertightness of the cladding system.

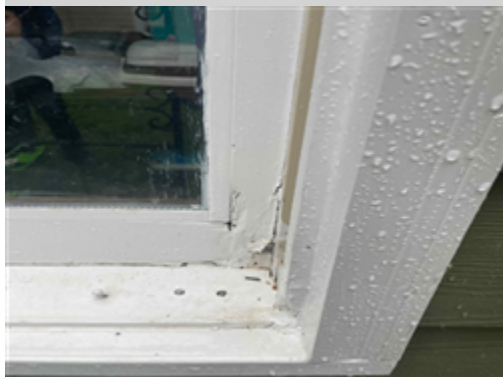
(B2 - 1.1) Windows

The Garage window(s) have soft and decayed wood in the sill, trim, sash area. Decay in the windows can result in leaking and water penetration and should be repaired as soon as possible. All windows should be inspected for similar damage as repairs are made. A licensed general contractor should be consulted to evaluate the extent of the damage and make necessary repairs.

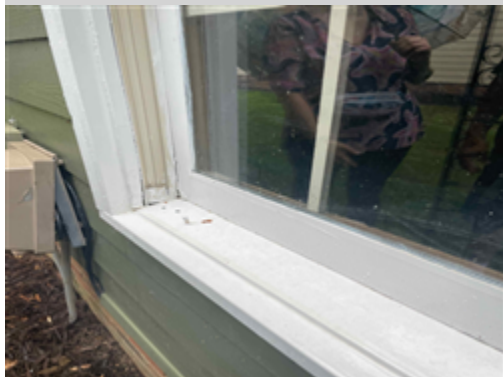
(B2 - 1.2) Windows

The Garage window(s) have soft and decayed wood in the sill, trim, sash area. Decay in the windows can result in leaking and water penetration and should be repaired as soon as possible. All windows should be inspected for similar damage as repairs are made. A licensed general contractor should be consulted to evaluate the extent of the damage and make necessary repairs.

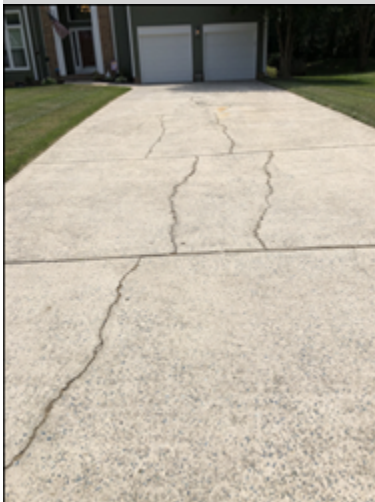
(B4 - 1.1) Driveway

The driveway is cracked and displaced. The raised section of the driveway has created a path for water penetration under the slab and a trip or fall hazard. A licensed general contractor should be consulted for further evaluation and repair.

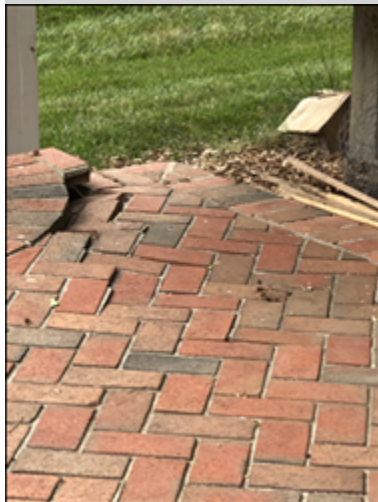
(B4 - 3.1) Patio

The brick pavers/tiles on the patio pad are cracked/loose. The loose brick/tile has resulted in an uneven walking surface and created an opening where water could become trapped resulting in additional damage. A licensed general contractor should be consulted for further evaluation, to determine the extent of the concern, and to make necessary repairs.

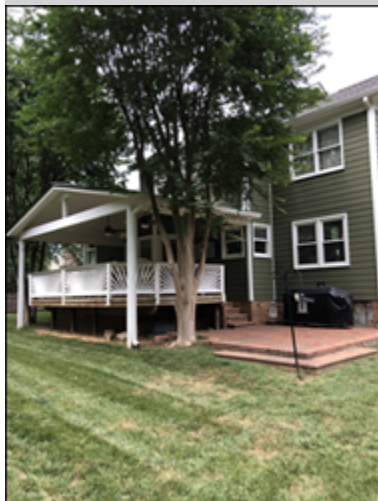
(B5 - 1.1) Vegetation

The vegetation around the perimeter of the home is over grown and blocks the air circulation around the home. The growth also limited the inspection access. A landscaping company should be consulted to correct the over growth and the inspection should be completed prior to purchase.

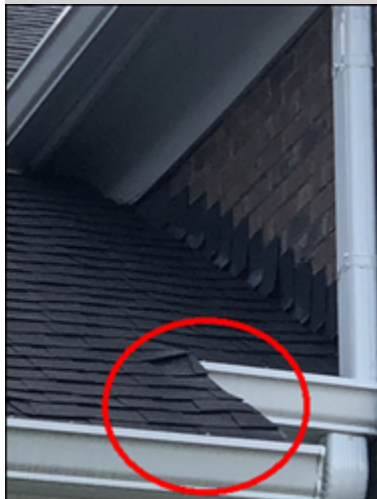
(C1 - 1.1) Main House

A raised shingle on the gutter area of the roof surface is in need of repair/replacement. Displaced shingles could indicate an underlying problem with the shingle installation, roof sheathing, or attic conditions. A licensed roofing contractor should be consulted for a complete evaluation and repair to ensure the weathertightness of the roof covering system.

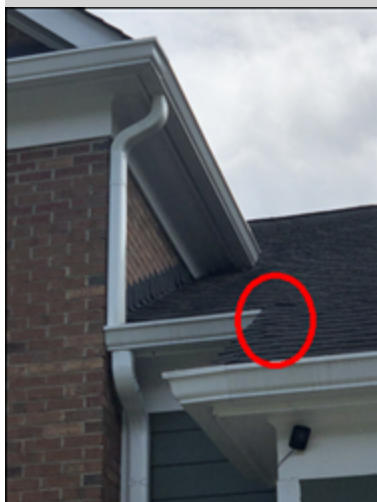
(C1 - 1.2) Main House

A raised shingle on the gutter area of the roof surface is in need of repair/replacement. Displaced shingles could indicate an underlying problem with the shingle installation, roof sheathing, or attic conditions. A licensed roofing contractor should be consulted for a complete evaluation and repair to ensure the weathertightness of the roof covering system.

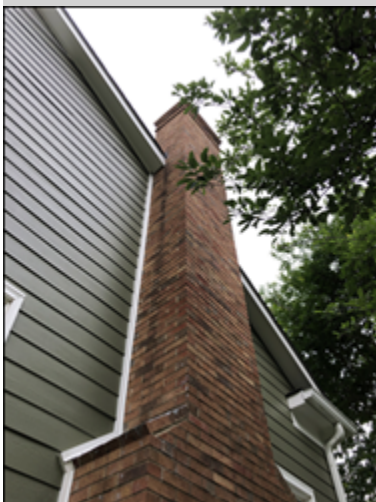
(C4 - 1.2) Main House

The chimney flue liner and masonry crown are not visible during the home inspection. The chimney flue liner contains the fire and exhaust when the chimney is in use. The masonry crown prevents water penetration between the masonry chimney body and the flue liner. Chimneys flues should be cleaned and inspected annually if used for gas or wood burning. Chimney crowns should be maintained and replaced every 5 to 7 year.

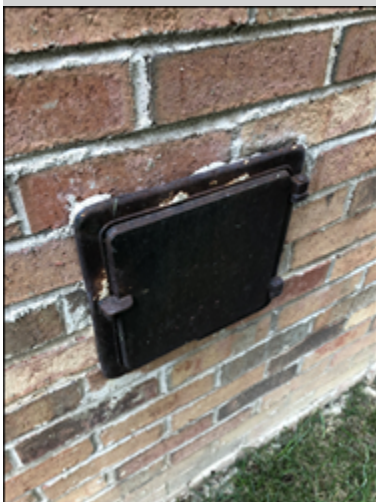
(C4 - 1.3) Main House

The fireplace cleanout door is rusted shut and in need of repair/replacement. The cleanout door prevents active or hot embers from entering unprotected areas. The chimney needs a complete evaluation and invasive inspection prior to use. A chimney sweep and general contractors should be consulted for a complete evaluation of the chimney and to make necessary repairs to ensure that the chimney is safe and functional.

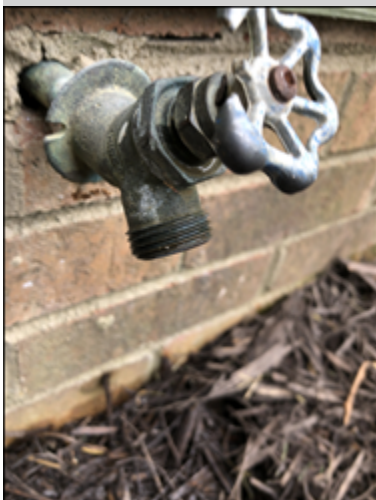
(D1 - 1.2) Exterior

The exterior faucet located on the front of the home have a broken handle and was not tested. A licensed plumbing contractor or a general repair specialist should be consulted to make necessary repairs to ensure that the faucet is operational and does not drip or leak in the foundation area.

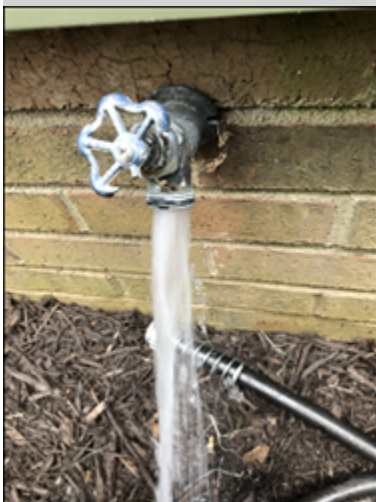
(D1 - 1.3) Exterior

The exterior faucet located on the front/back side of the home have a broken handle and was not tested. A licensed plumbing contractor or a general repair specialist should be consulted to make necessary repairs to ensure that the faucet is operational and does not drip or leak in the foundation area.

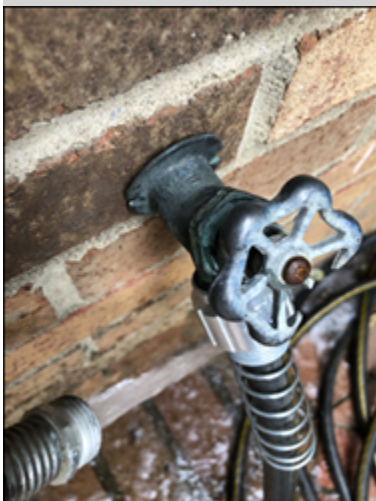
(D1 - 1.5) Exterior

The exterior faucet located rear is not a frost free or anti siphon fixture. Although not required when this home was built, the anti-siphon faucet prevents back flow related to pressure drops to prevent contamination of the water supply and piping systems. The buyer should consider upgrading the exterior faucets.

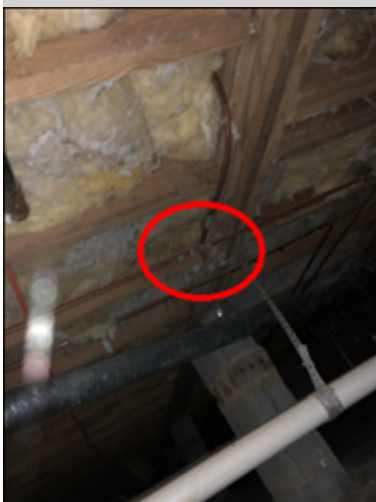
(D1 - 2.2) Crawl Space

The plumbing fixtures in the home have blue stains. Copper can produce blue-green stains on sinks, porcelain bathroom fixtures, and even on laundry. Copper levels in water are typically elevated when the PH level of the water supply approaches acidic levels. Copper in the water can produce a metallic taste, a blue-green color, and a possible odor to the water. A plumber should be consulted to inspect the condition of the copper plumbing and analyze the water source.

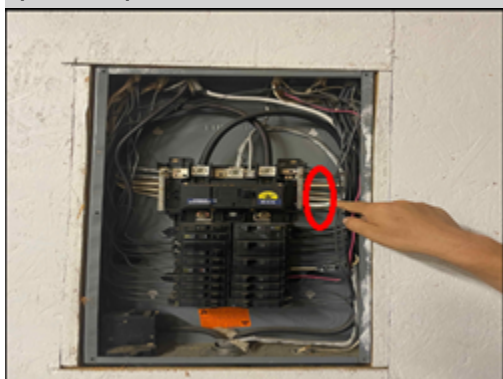
(E2 - 1.1) Main Panel #1

The ground/neutral bus bar located on the left/right side of the panel has several double taps where two neutral conductors are connected together under one screw. This condition presents a safety hazard that could result in interrupted service, property damage, and serious personal injury. A licensed electrical contractor should be consulted for a complete evaluation and to make necessary repairs.

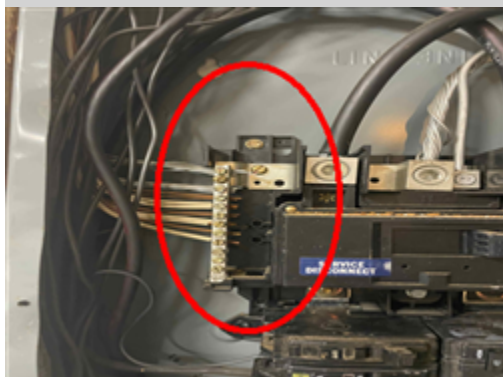
(E2 - 1.2) Main Panel #1

The ground/neutral bus bar located on the left/right side of the panel has several double taps where two neutral conductors are connected together under one screw. This condition presents a safety hazard that could result in interrupted service, property damage, and serious personal injury. A licensed electrical contractor should be consulted for a complete evaluation and to make necessary repairs.

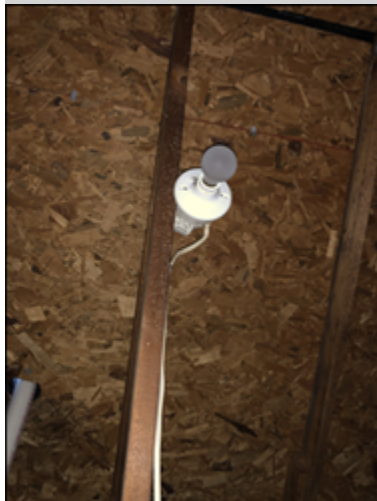
(E5 - 2.1) Attic

The light fixture was not functional when tested. This could indicate a defective bulb or other more serious problem such as faulty wiring or a defective fixture. A licensed electrical contractor should be consulted for further evaluation and repair.

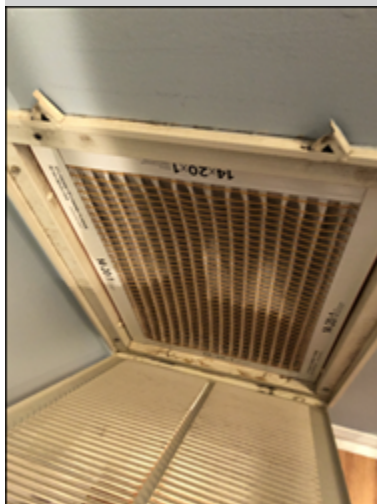
(G2 - 1.1) Cooling Unit #1

The return air filter in the home was found to be clogged. A clogged filter reduces add load to the system that can result in premature failures. A HVAC contractor should be consulted for a complete evaluation and service of the system to ensure reliable and proper operation.

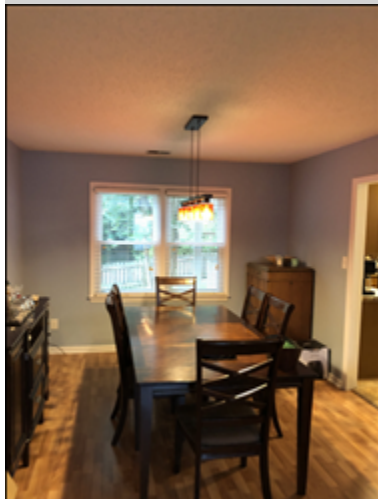
(H1 - 3.1) Dining Room

Interior floors were noted to slope toward adjacent walls/rooms. The slope was more than would be typically expected. An engineer should be consulted to evaluate the structure of the home to determine the significance of this concern and if repairs are necessary.

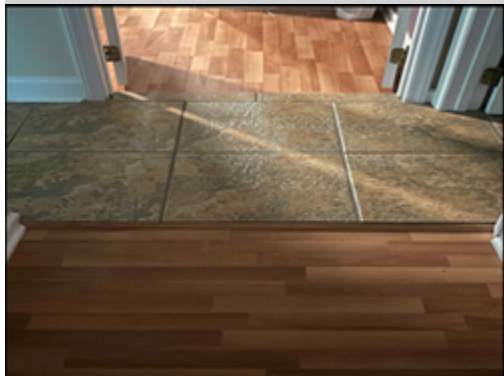
(H1 - 4.1) Hall

This transition in the hall between the master Kitchen and Laundry is a trip hazard. A general contractor should be consulted look at to have continuous floor.

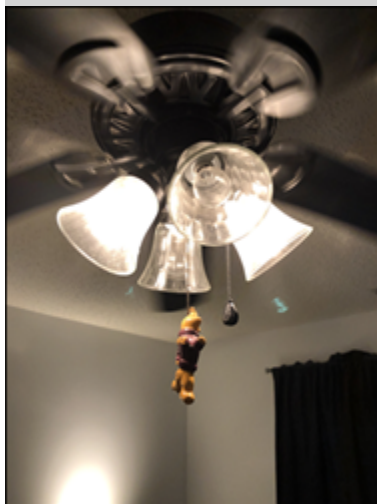
(H1 - 9.1) Bedroom #1

The light fixture located was not functional when tested. This could indicate a defective bulb or other more serious problem such as faulty wiring or a defective fixture, further evaluation and repair is needed. A licensed electrical contractor should be consulted for further evaluation and repair.

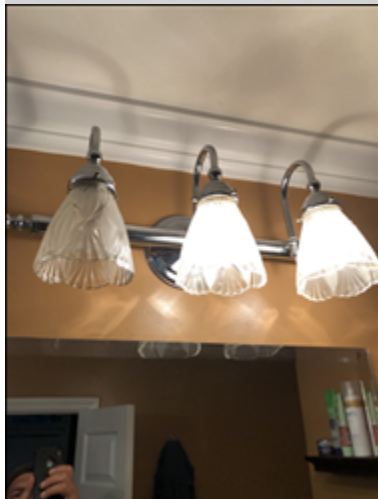
(H3 - 2.1) Bathroom: Master

The light fixture was not functional when tested. This could indicate a defective bulb or other more serious problem, further evaluation is needed. A licensed electrical contractor should be consulted for further evaluation and repair.

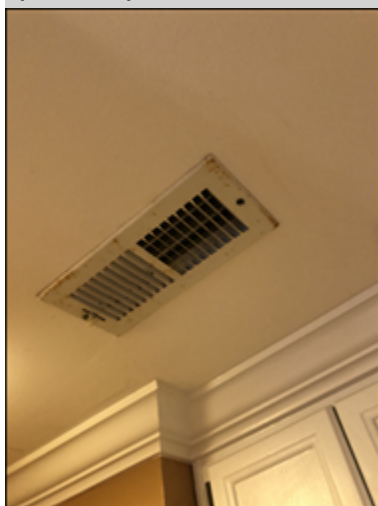
(H3 - 2.2) Bathroom: Master

The HVAC registers were rusted and stains suggests a history of condensation. This could indicate improper HVAC system operation, restricted air flow, air leaks and or poor insulation. A HVAC contractor should be consulted for a complete evaluation to determine the cause of the condensation and if related damage is present. Fan for bathroom not strong enough or in wrong spot.

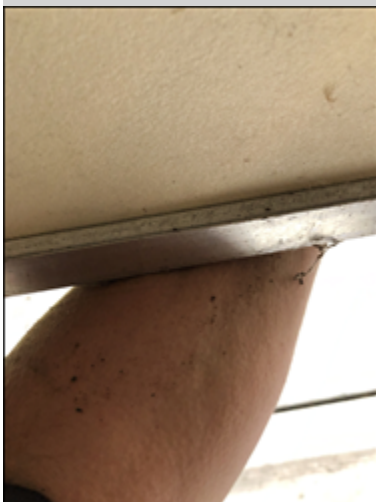
(H4 - 1.1) Garage

The garage door needs adjustment and repair. The door did not stop/reverse when the path was interrupted. A garage door installation company or a licensed general contractor should be consulted for evaluation and repair to ensure that the door operates safely and properly.

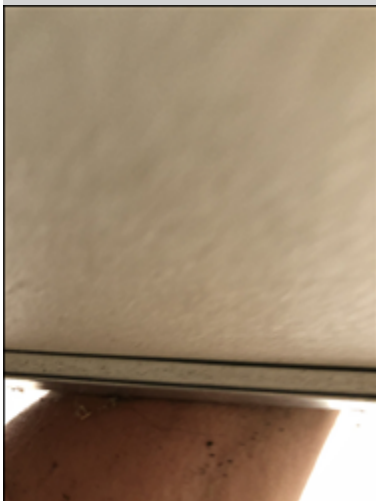
(H4 - 1.2) Garage

The garage door needs adjustment and repair. The door did not stop/reverse when the path was interrupted. A garage door installation company or a licensed general contractor should be consulted for evaluation and repair to ensure that the door operates safely and properly.

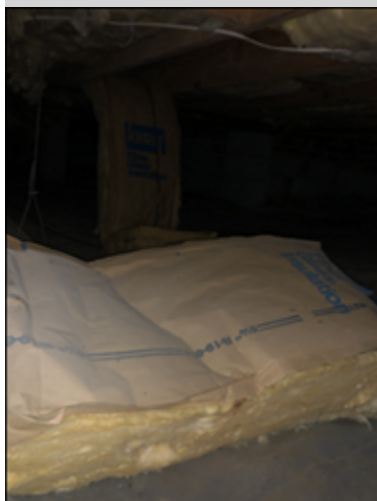
(I1 - 1.2) Crawl Space: All Accessible Areas

A section of insulation in the crawl space is missing. Improper insulation installation could result in condensation, over heating of the building components, and inadequate conditioning of the living areas. A licensed general contractor should be consulted for repair/replacement.

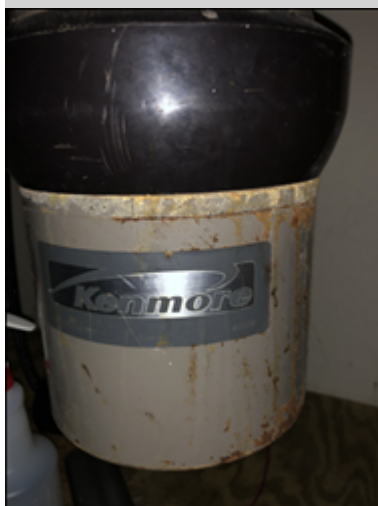
(J1 - 2.1) Garbage Disposal

The casing of the disposal is corroded and damaged. The corrosion could indicate a history of leaks or exposure to harsh chemicals. Appliances should be repaired and inspected prior to purchase to ensure safe and proper operation. An appliance repair specialist should be consulted for full evaluation to determine the cause of the corrosion and repair/replace as needed.
