Property Inspection Report

Report Number: 060322CF1

Sample Report
Charlotte, North Carolina 28210

Date of Inspection: Saturday, June 4, 2022

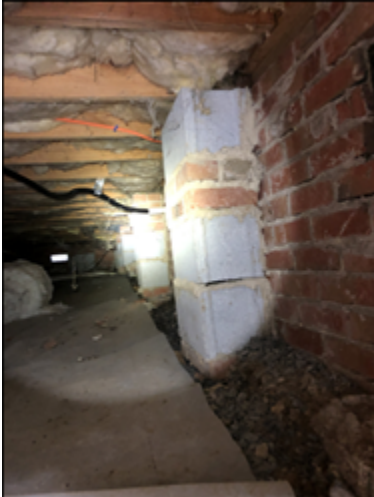
(A1 - 1.1) Main House

Foundation

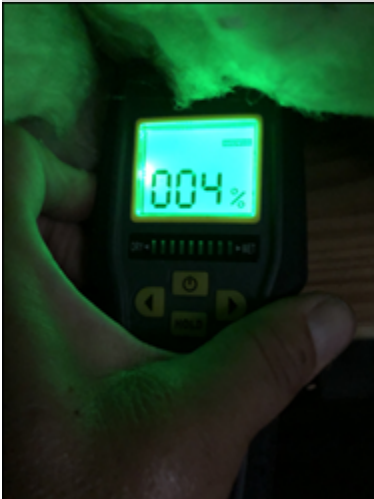
(A1 - 1.2) Main House

Crawlspace moisture

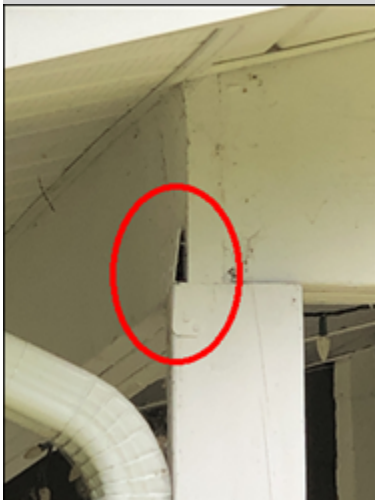
(A2 - 1.3) Porch

The column located left is not securely fastened at the top plate. Lateral bracing or fastening of the column base reduces the probability of column movement when impacted or exposed to loading. A licensed general contractor should be consulted for further evaluation and to make necessary repairs.

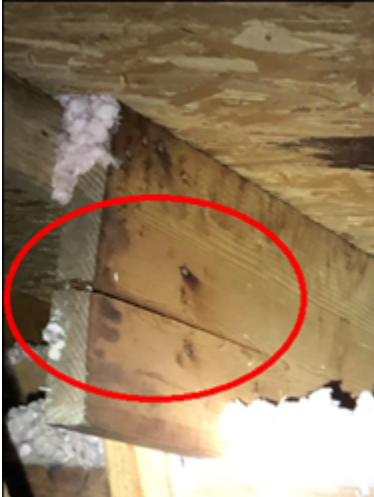
(A6 - 1.1) Main House

From the attic, a rafters was note to be cracked. Rafters are key components of the roof system and need to be repaired to prevent framing movement and further damage. An engineer should be consulted for further evaluation to determine the significance and cause of the concern and outline necessary repairs to ensure the stability of the structure.

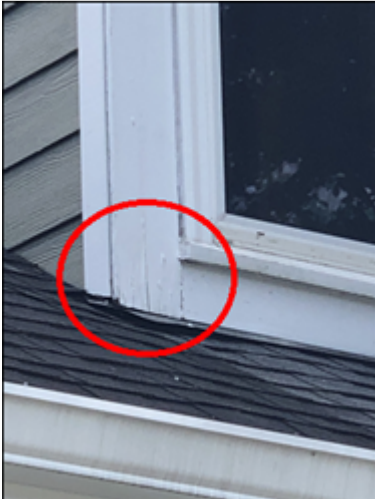
(B1 - 1.3) Main House Front

The wood trim pieces for the siding system are decayed at the corner locations. The corner trim provides a finished edge for siding and protects the underlying sheathing. Decay of the corner trim can allow water to enter behind the siding and result in damage to the framing. A licensed general contractor should be consulted for an invasive inspection to determine the extent of the damage to underlying components and make necessary repairs to ensure the weathertightness of the cladding system.

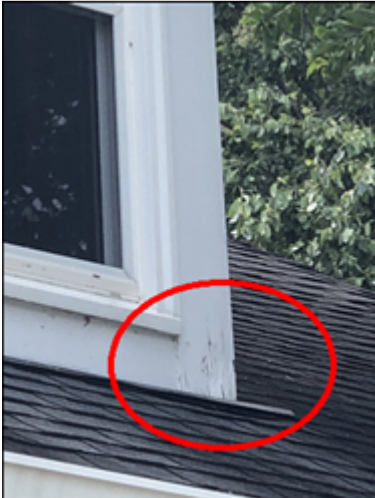
(B1 - 1.4) Main House Front

The wood trim pieces for the siding system are decayed at the corner locations. The corner trim provides a finished edge for siding and protects the underlying sheathing. Decay of the corner trim can allow water to enter behind the siding and result in damage to the framing. A licensed general contractor should be consulted for an invasive inspection to determine the extent of the damage to underlying components and make necessary repairs to ensure the weathertightness of the cladding system.

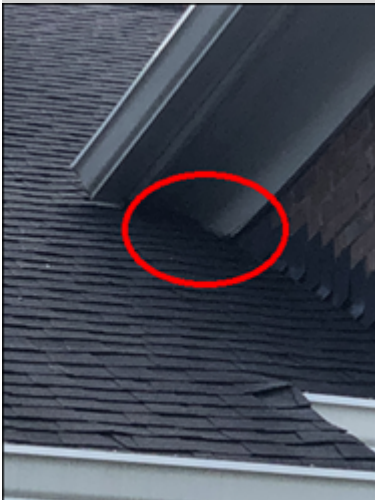
(B1 - 1.5) Main House Front

The wood trim pieces for the siding system are decayed at the corner locations. The corner trim provides a finished edge for siding and protects the underlying sheathing. Decay of the corner trim can allow water to enter behind the siding and result in damage to the framing. A licensed general contractor should be consulted for an invasive inspection to determine the extent of the damage to underlying components and make necessary repairs to ensure the weathertightness of the cladding system.

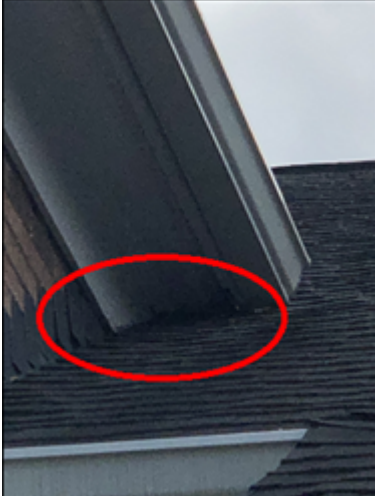
(B1 - 1.6) Main House Front

The wood trim pieces for the siding system are decayed at the corner locations. The corner trim provides a finished edge for siding and protects the underlying sheathing. Decay of the corner trim can allow water to enter behind the siding and result in damage to the framing. A licensed general contractor should be consulted for an invasive inspection to determine the extent of the damage to underlying components and make necessary repairs to ensure the weathertightness of the cladding system.

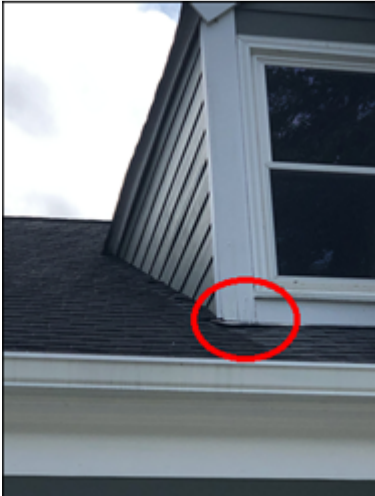
(B1 - 1.7) Main House Front

The wood trim pieces for the siding system are decayed at the corner locations. The corner trim provides a finished edge for siding and protects the underlying sheathing. Decay of the corner trim can allow water to enter behind the siding and result in damage to the framing. A licensed general contractor should be consulted for an invasive inspection to determine the extent of the damage to underlying components and make necessary repairs to ensure the weathertightness of the cladding system.

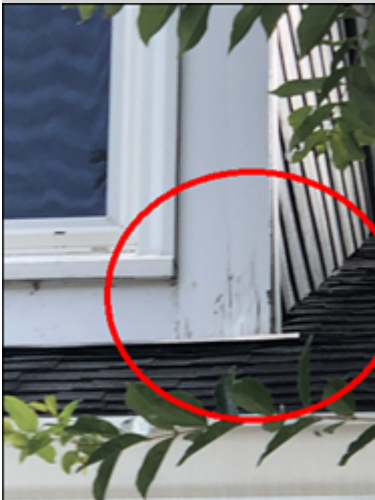
(B1 - 1.8) Main House Front

The wood trim pieces for the siding system are decayed at the corner locations. The corner trim provides a finished edge for siding and protects the underlying sheathing. Decay of the corner trim can allow water to enter behind the siding and result in damage to the framing. A licensed general contractor should be consulted for an invasive inspection to determine the extent of the damage to underlying components and make necessary repairs to ensure the weathertightness of the cladding system.

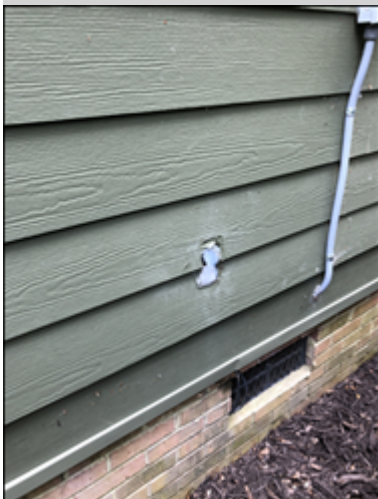
(B1 - 2.2) Main House Right

Where the old AC was located

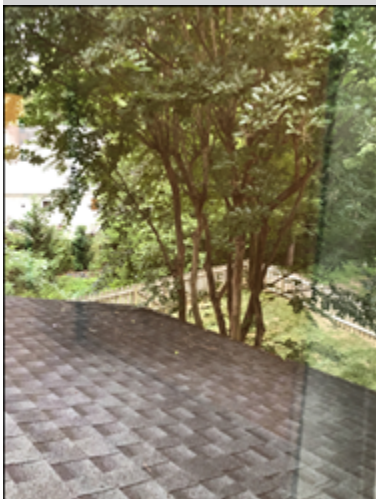
(B5 - 1.2) Vegetation

The vegetation around the perimeter of the home is over grown and blocks the air circulation around the home. The growth also limited the inspection access. A landscaping company should be consulted to correct the over growth and the inspection should be completed prior to purchase.

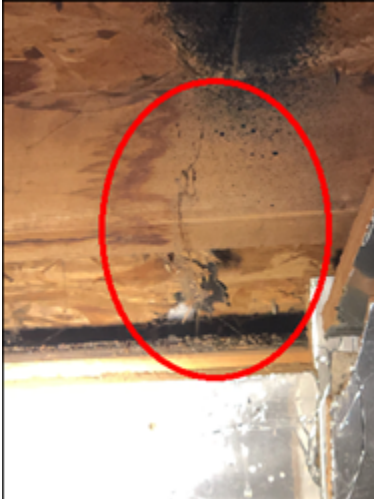
(C1 - 2.1) Main House Second Story Section

The wood panel sheathing for the roofing structure is orientated strand board (OSB). The wood composite panels were noted to be delaminated or damaged in a few areas of the attic. Large wafer wood pieces appear to be loose along the exposed surfaces and a few ceiling areas have significant build up from wafer pieces that has fallen in the insulation. This evidence could indicate a problem with ventilation, moisture exposure and or a manufacturer's defect. A professional engineer should be consulted to evaluate the condition of the structural panels to determine the cause/significance of the concern and outline repairs as needed to ensure stability and durability of the roof system.

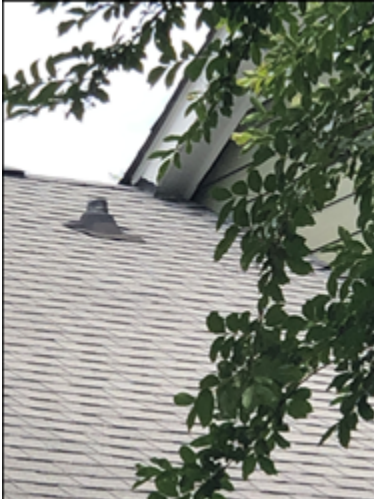
(C3 - 2.1) Main House

The clearance for main plumbing vent is lower than typically expected. The clearance is important to ensure that the vent does not get blocked by debris or snow. The upper section of the pipe acts as a vent for waste gases, the lower section of the pipe that carries waste water to the main system. If the main pipe does not properly exit to the exterior sewer gases can enter the home. A licensed plumbing contractor should be consulted for a complete evaluation to determine the significance of this concern and to make necessary repairs.

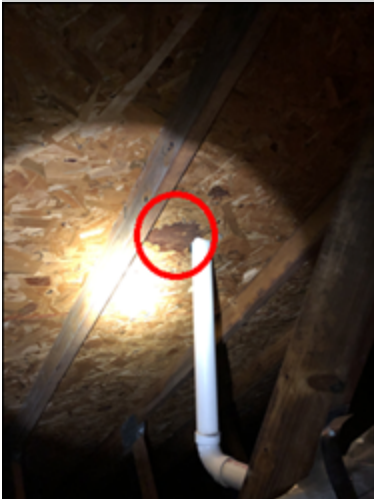
(C3 - 2.2) Main House

From the attic, the plywood sheathing is delaminating. Plywood is made of three or more thin layers of wood bonded together with an adhesive. When the layers separate, the plywood loses stiffness and strength. Delamination can be the result of age, water penetration and or improper ventilation. A licensed contractor should be consulted for further evaluation to determine the cause of the delamination and to make necessary repairs.

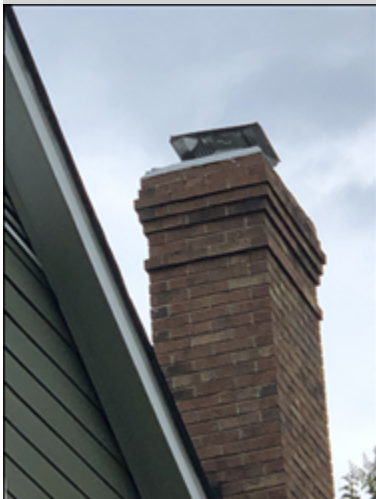
(C4 - 1.1) Main House

A chimney specialist should be consulted to clean and inspect the flue liner, firebox, and the chimney crown to ensure that if the chimney is deemed stable by the engineer, it is also safe to use.

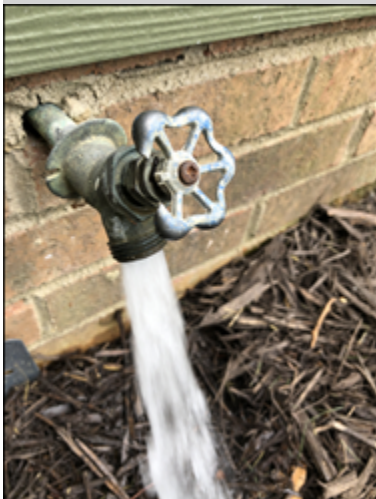
(D1 - 1.1) Exterior

The exterior faucet located front is not a frost free or anti siphon fixture. Although not required when this home was built, the anti-siphon faucet prevents back flow related to pressure drops to prevent contamination of the water supply and piping systems. The buyer should consider upgrading the exterior faucets.

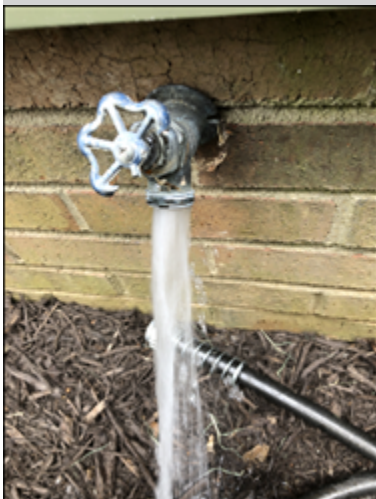
(D1 - 1.4) Exterior

The exterior faucet located front is not a frost free or anti siphon fixture. Although not required when this home was built, the anti-siphon faucet prevents back flow related to pressure drops to prevent contamination of the water supply and piping systems. The buyer should consider upgrading the exterior faucets.

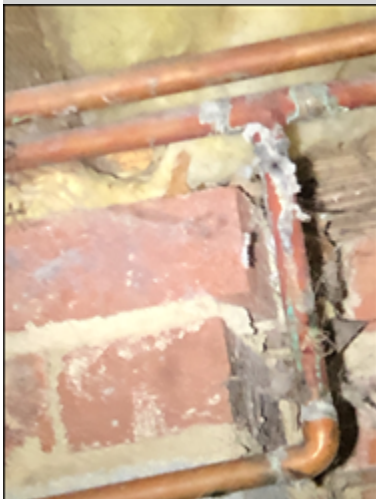
(D1 - 2.1) Crawl Space

The plumbing fixtures in the home have blue stains. Copper can produce blue-green stains on sinks, porcelain bathroom fixtures, and even on laundry. Copper levels in water are typically elevated when the PH level of the water supply approaches acidic levels. Copper in the water can produce a metallic taste, a blue-green color, and a possible odor to the water. A plumber should be consulted to inspect the condition of the copper plumbing and analyze the water source.

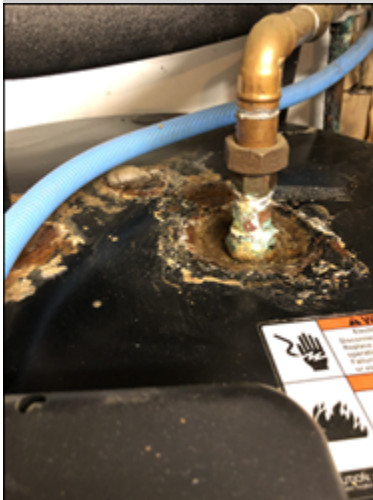
(D3 - 1.3) Unit #1

The water heating unit for this home has heavy corrosion at the supply line connections to the tank. A licensed plumbing contractor should be consulted to evaluate the system and repair/replace as needed to ensure safe and reliable hot water supply.

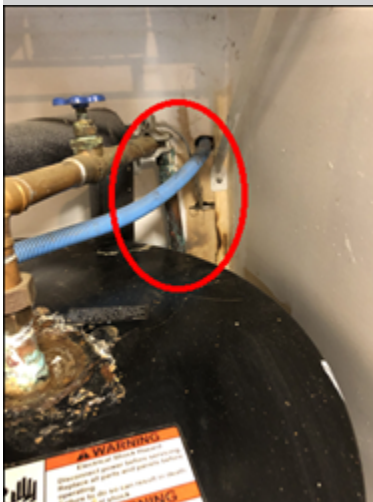
(D3 - 1.4) Unit #1

The water heating unit for this home was found to be in poor condition. The unit has heavy corrosion of the supply line connections. A licensed plumbing contractor should be consulted to evaluate the system and repair/ replace as needed to ensure safe and reliable hot water supply.

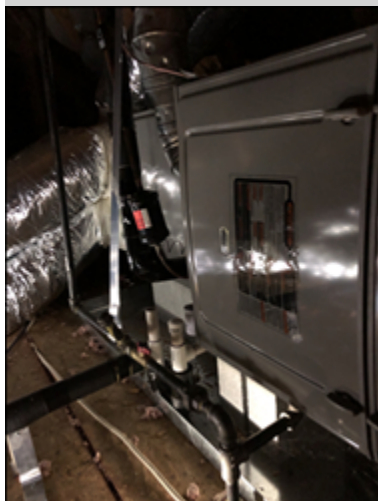
(F1 - 1.1) Heating Unit #1

All gas appliances should be serviced seasonally and inspected annually. Gas furnaces that are over 7 years old should have a heat exchanger inspection as part of their annual winter service.

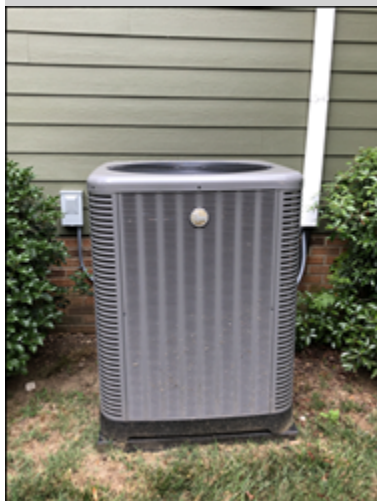
(G1 - 1.1) Cooling Unit #1

All AC systems should be serviced seasonally and inspected annually, the service should include cleaning and inspecting the coils.

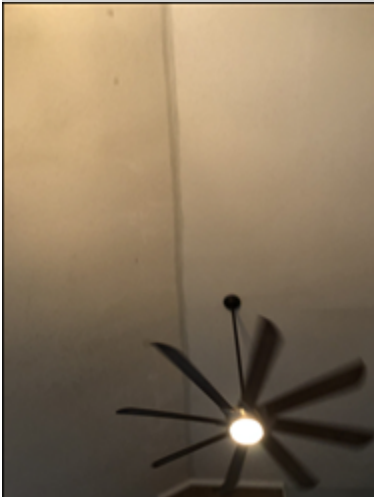
(H1 - 2.2) Living Room

Evidence suggests that the ceiling has been repaired/painted. The owner should be asked for disclosure related to the extent of any related repairs, leaks or problems and the reason the ceiling was painted. New paint can limit the inspection as all history of defects or concerns are not visible.

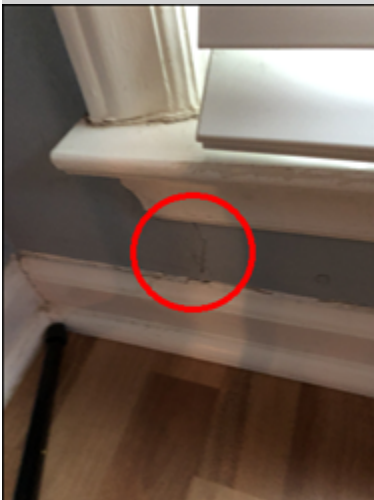
(H1 - 2.3) Living Room

The wall is cracked. No related concerns were noted in the throughout the other inspection areas. The buyer should review the area of concern. If additional concerns or questions are present, invasive inspection and repair will be needed.

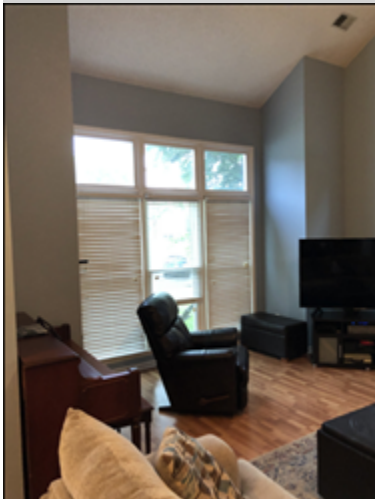
(H1 - 2.4) Living Room

Livingroom

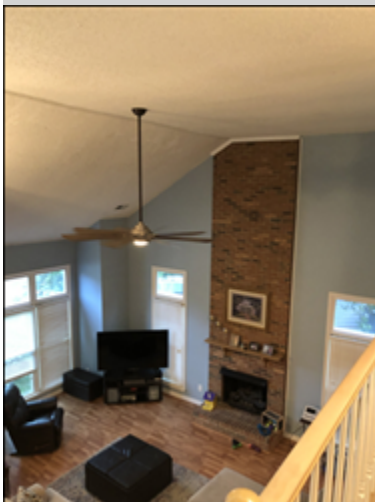
(H1 - 2.6) Living Room

Livingroom

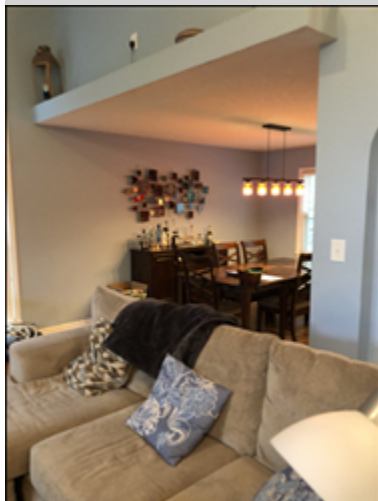
(H1 - 3.2) Dining Room

Dining room

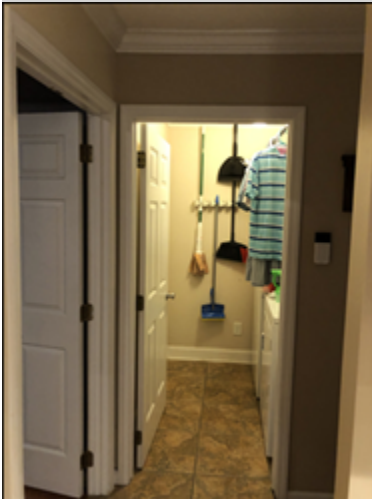
(H1 - 5.1) Laundry

Laundry

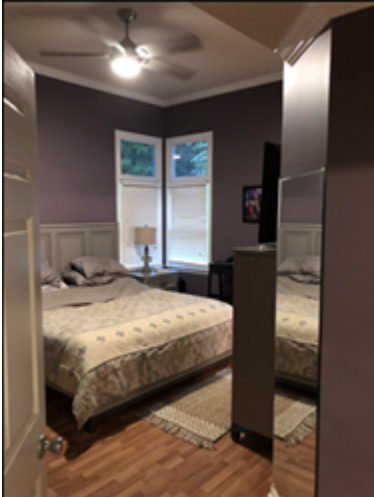
(H1 - 6.1) Bedroom: Master

A properly functioning smoke detector is vital to the safety of a home. Smoke detector should be replaced or updated every 5 to 7 years and batteries changed annually. Verification is recommended

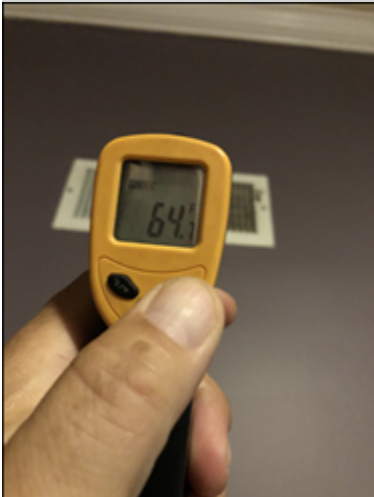
(H1 - 6.2) Bedroom: Master

Cold air reading

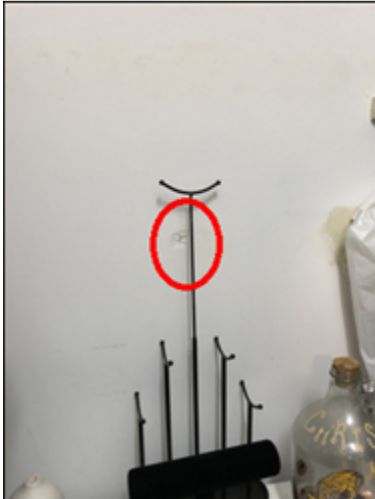
(H1 - 6.4) Bedroom: Master

cosmetic

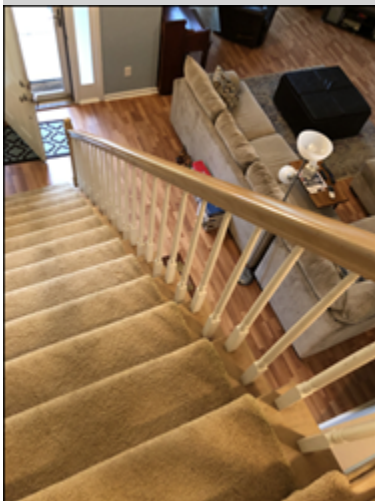
(H1 - 7.1) Stairway

The handrailing for the stairway is loose, too low, poor condition. A correct and secure handrail is essential to ensure safe use of the stairway to prevent fall hazards. A licensed general contractor should be consulted for evaluation and repair.

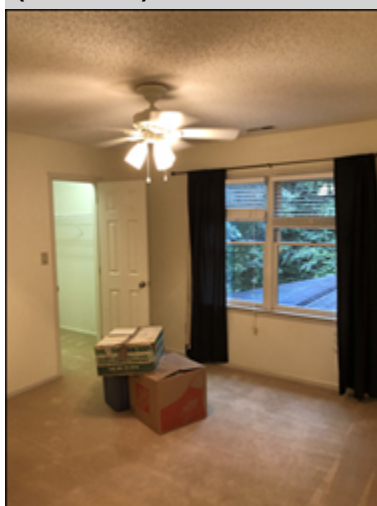
(H1 - 10.1) Bedroom #2

A properly functioning smoke detector is vital to the safety of a home. Smoke detector should be replaced or updated every 5 to 7 years and batteries changed annually. Verification is recommended

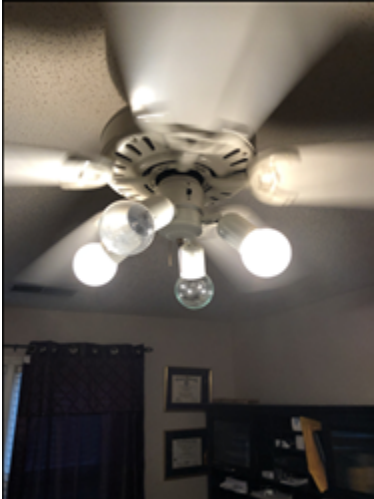
(H1 - 11.1) Office

The light fixture located was not functional when tested. This could indicate a defective bulb or other more serious problem such as faulty wiring or a defective fixture, further evaluation and repair is needed. A licensed electrical contractor should be consulted for further evaluation and repair.

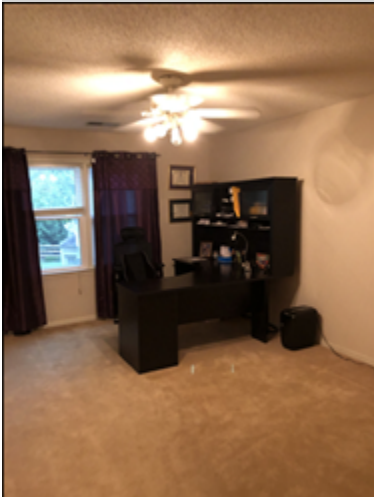
(H1 - 11.2) Office

A properly functioning smoke detector is vital to the safety of a home. Smoke detector should be replaced or updated every 5 to 7 years and batteries changed annually. Verification is recommended

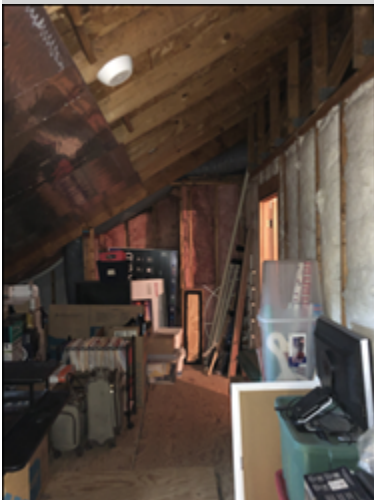
(H1 - 11.3) Office

Storage of office

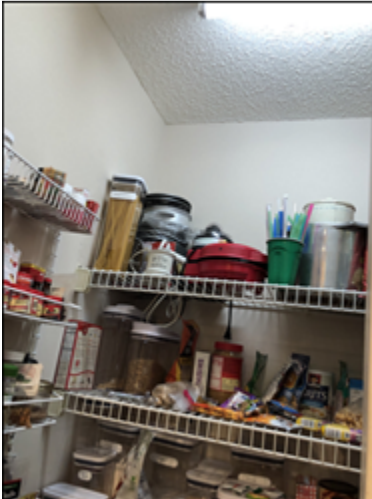
(H2 - 1.1) Kitchen

Pantry

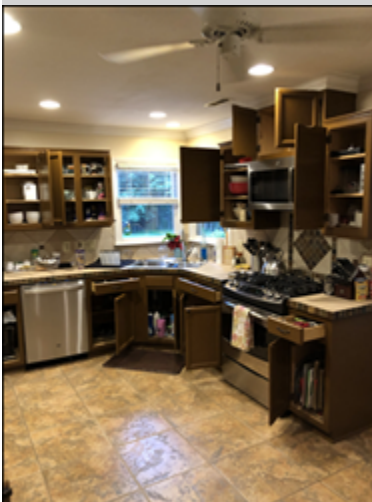
(H2 - 1.2) Kitchen

Cabinet check

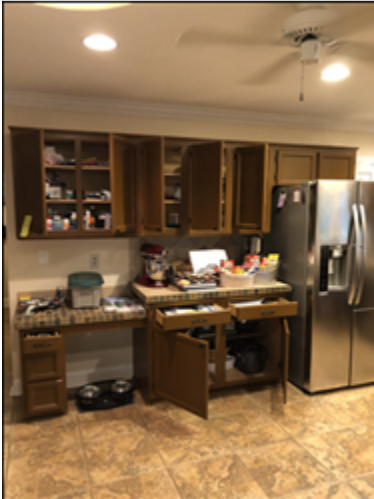
(H2 - 1.3) Kitchen

Cabinet check

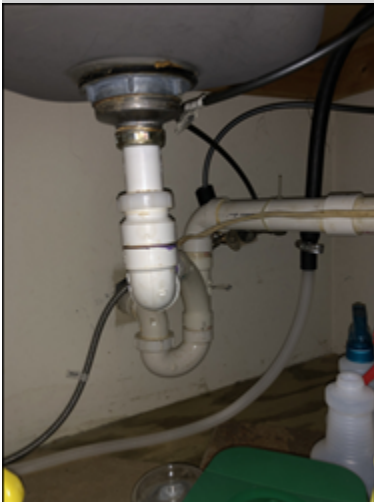
(H2 - 1.4) Kitchen

Under sink

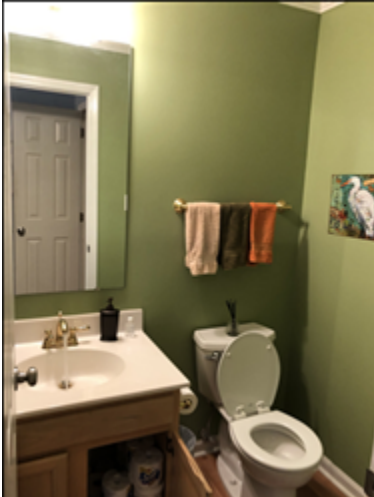
(H3 - 1.1) Half Bathroom #1

first floor

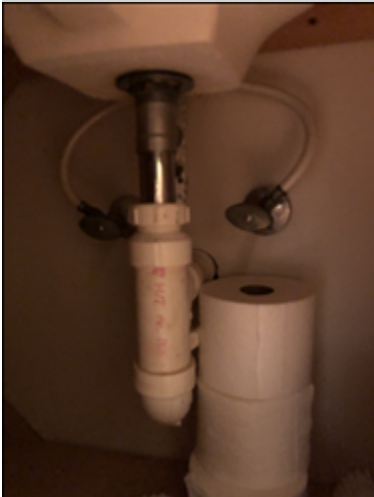
(H3 - 1.2) Half Bathroom #1

under sink

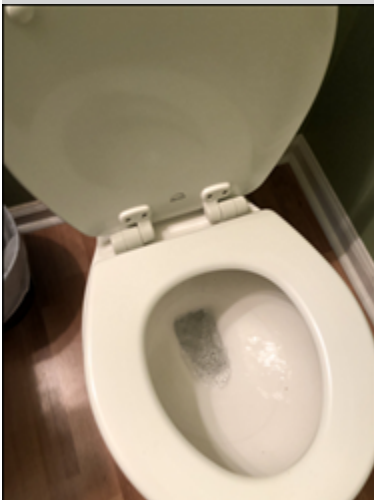
(H3 - 1.3) Half Bathroom #1

Toilet

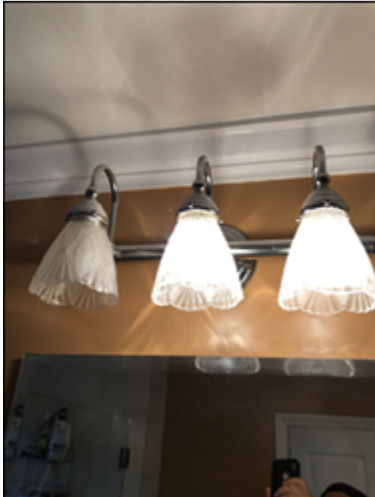
(H3 - 2.3) Bathroom: Master

The light fixture was not functional when tested. This could indicate a defective bulb or other more serious problem, further evaluation is needed. A licensed electrical contractor should be consulted for further evaluation and repair.

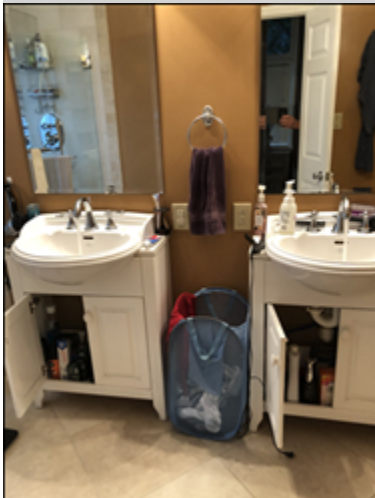
(H3 - 2.4) Bathroom: Master

Master bathroom

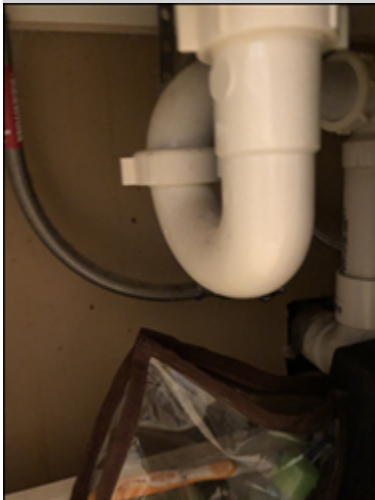
(H3 - 2.5) Bathroom: Master

Under sink

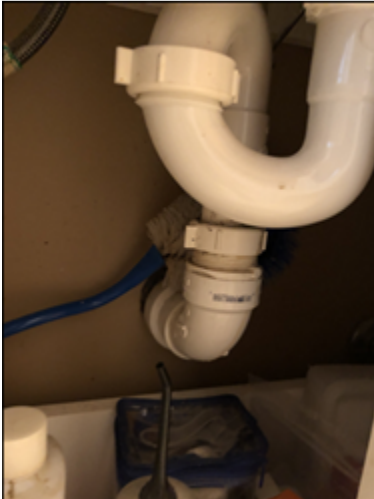
(H3 - 2.6) Bathroom: Master

Under sink

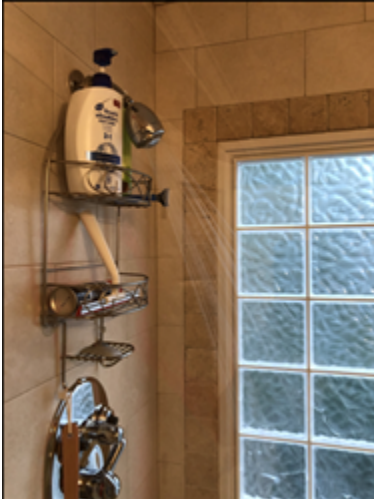
(H3 - 2.8) Bathroom: Master

Shower

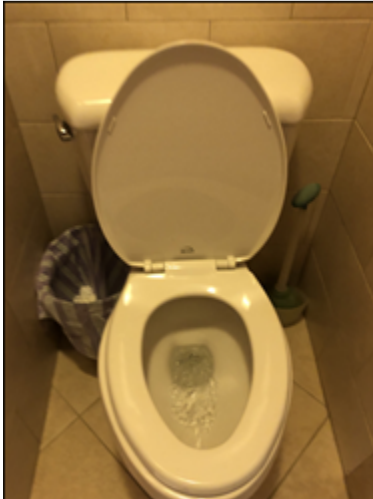
(H3 - 2.9) Bathroom: Master

Toilet

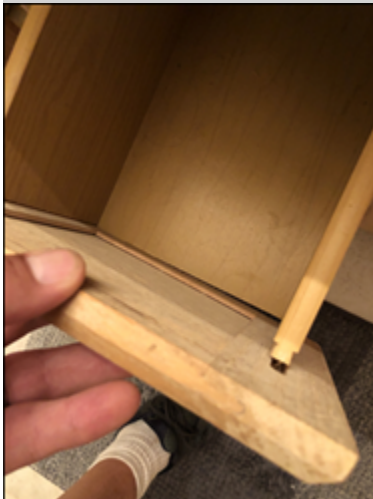
(H3 - 3.1) Bathroom #1

The cabinets are in poor condition and in need of repair/replacement. The following concerns were noted at the time of the inspection:

1. Loose doors

A general repair specialist or licensed general contractor should be consulted to evaluate and repair/replace the cabinets as need to ensure that they are functional and secure.

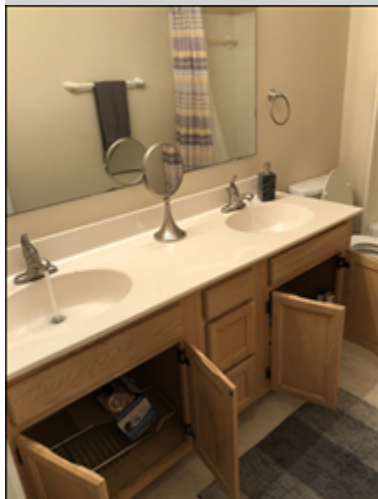
(H3 - 3.2) Bathroom #1

Cabinet check

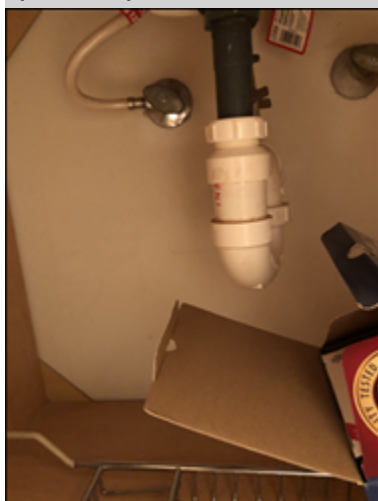
(H3 - 3.3) Bathroom #1

Under

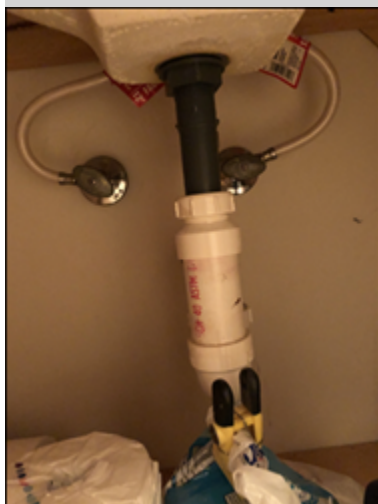
(H3 - 3.4) Bathroom #1

Under

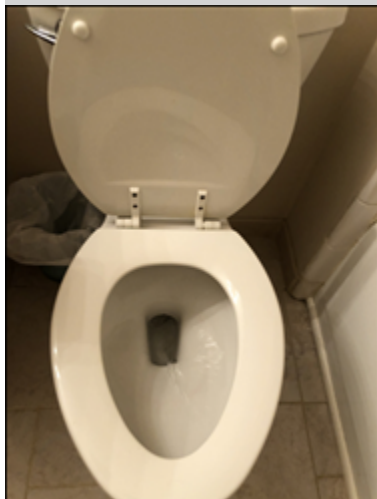
(H3 - 3.5) Bathroom #1

Toilet

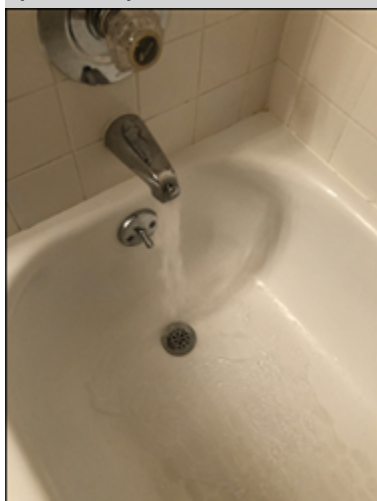
(H3 - 3.6) Bathroom #1

Tub

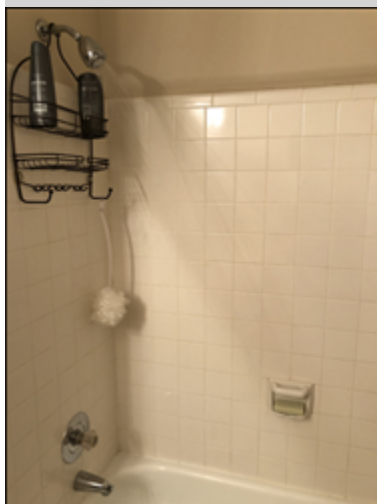
(H3 - 3.7) Bathroom #1

Shower

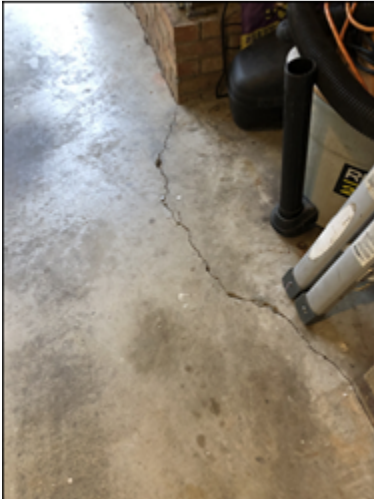
(H4 - 1.3) Garage

The garage floor has cracked in an uncontrolled fashion. The crack is of a measurable width and/or the floor planes separated by the crack are uneven. An engineer should be consulted to evaluate the floor slab and foundation to determine the significance of this concern and if repairs are necessary.

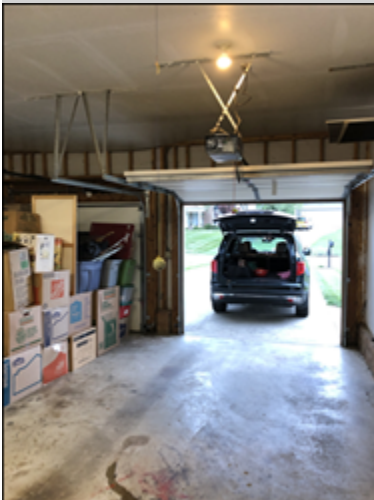
(H4 - 1.4) Garage

Storage

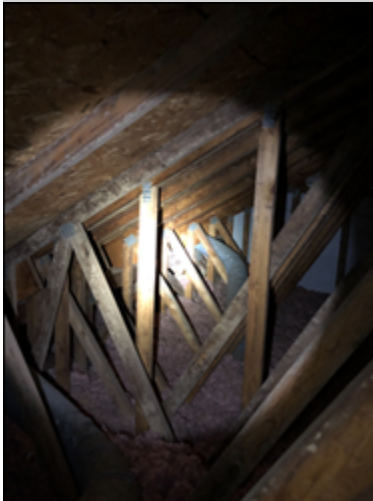
(H5 - 1.1) Attic: Unfinished

Attic

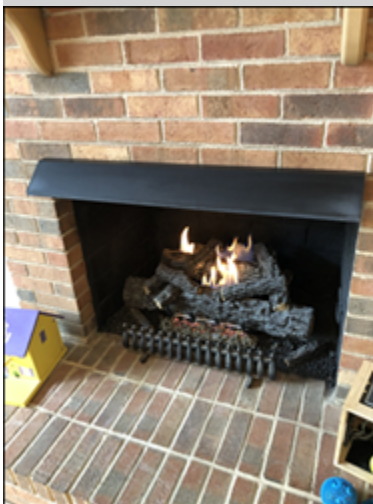
(H6 - 1.1) Fireplace: Masonry

Fireplace

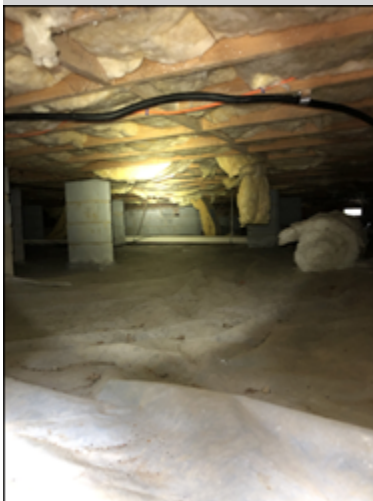
(I1 - 1.1) Crawl Space: All Accessible Areas

A section of insulation in the crawl space is missing. Improper insulation installation could result in condensation, over heating of the building components, and inadequate conditioning of the living areas. A licensed general contractor should be consulted for repair/replacement.

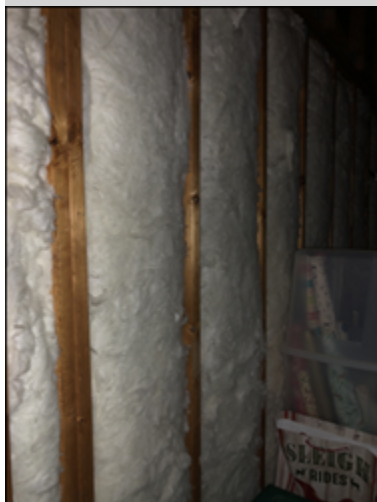
(I1 - 2.1) Attic

Wall insulation

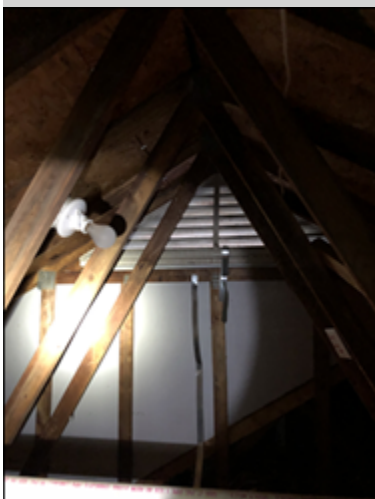
(I1 - 2.2) Attic

Gable vent

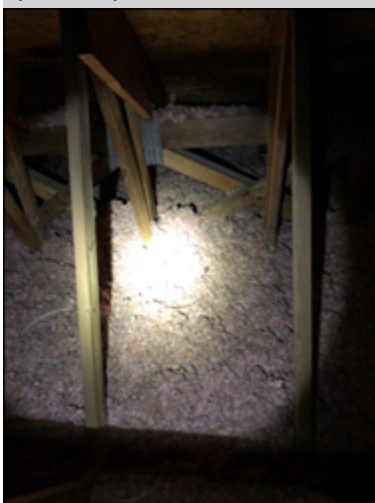
(I1 - 2.3) Attic

Insulation

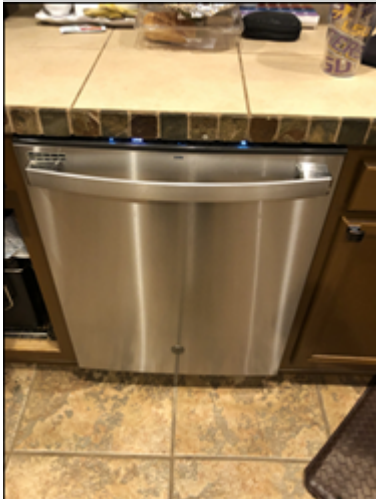
(J1 - 1.1) Dishwasher

Dishwasher

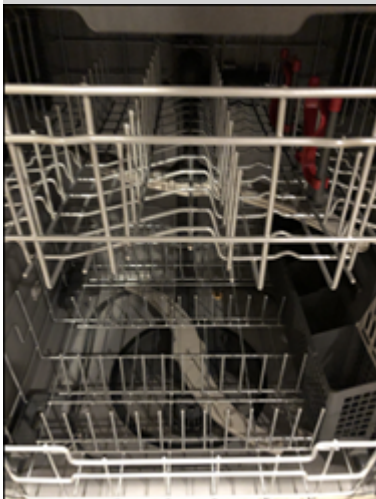
(J1 - 1.2) Dishwasher

inside

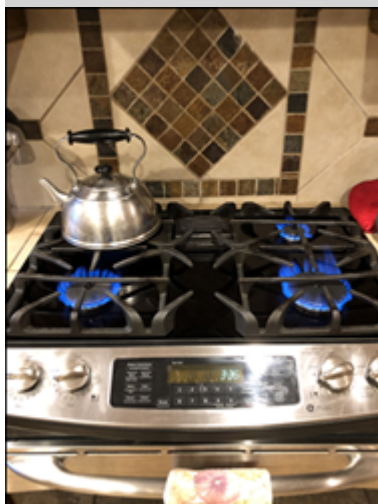
(J1 - 3.1) Range Top: Gas

Stove top

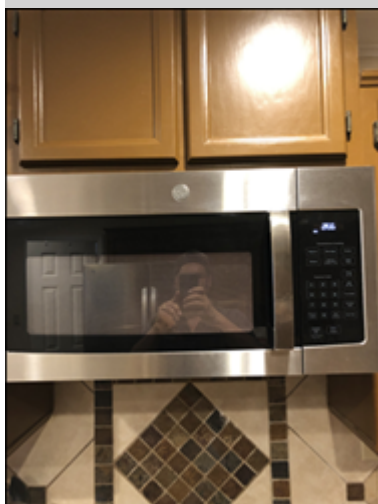
(J1 - 4.1) Microwave: Over Range

Microwave

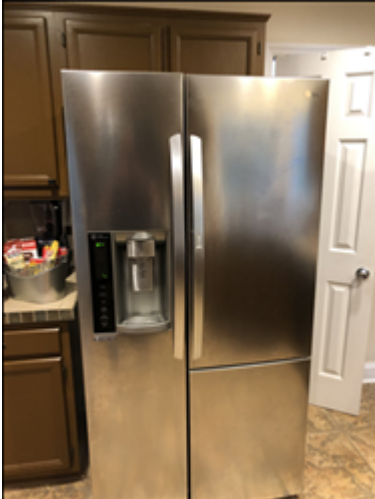
(J1 - 5.1) Refrigerator:

Fridge

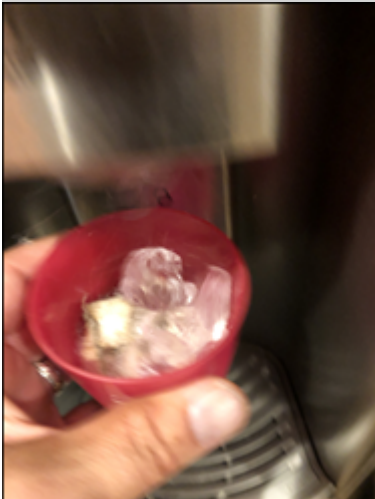
(J1 - 5.2) Refrigerator:

Ice and water

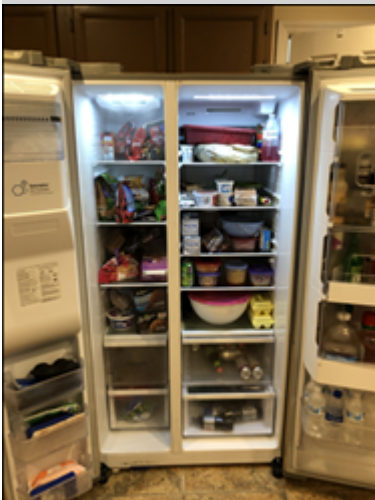
(J1 - 5.3) Refrigerator:

inside

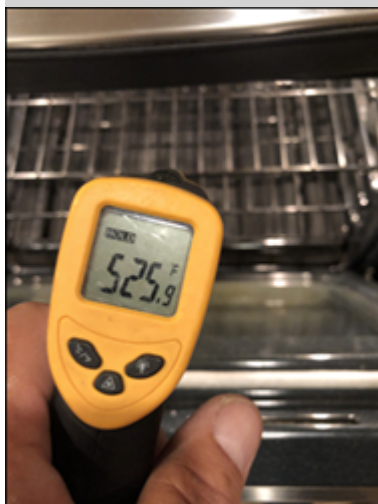
(J1 - 6.1) Oven: Gas

Oven
